DAMAGE DIAGNOSIS IN CONCRETE DAMS WITH PRESENTED EXPANSIVE DAMAGE BASED ON MEDICAL PROPAEDEUTICS

F. Pardo-Bosch, Ph.D.^a; and A. Aguado, Ph.D.^b

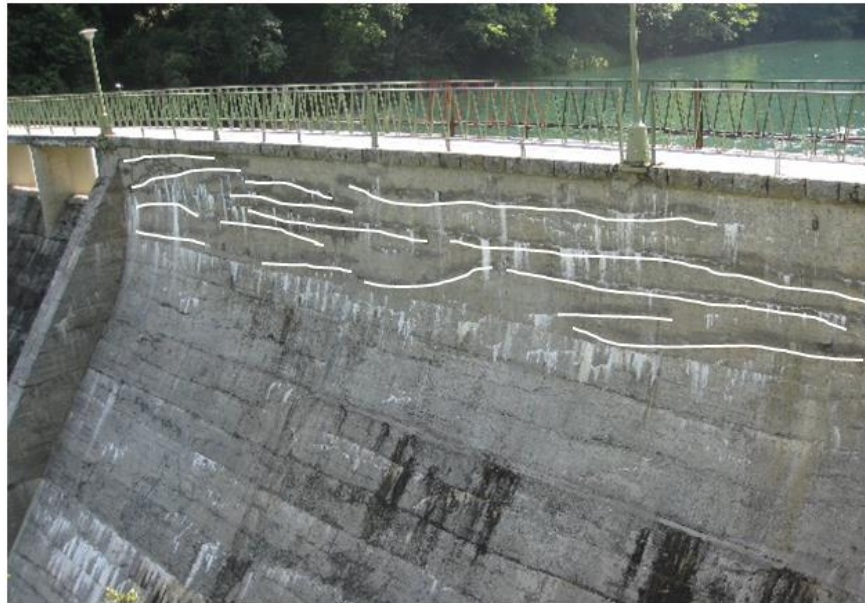
Fig. 4.- Horizontal fissure on a dam body

expansion is greater than that occurring closer to the foundation. In addition, the stiffness of the dam is greater at the base of the dam than at the top, making it easier to resist any action at the bottom of the structure than at the top of the blocks. This means that the expansion of the abutments at the top of the dam may be more significant. As a result of the terrain-structure interaction, in areas close to the crest (on both faces), longitudinal fissures may appear at a horizontal angle of between 0° and 45° , depending on the existing slope in the dam-terrain contact, as can be seen in Figure 4.

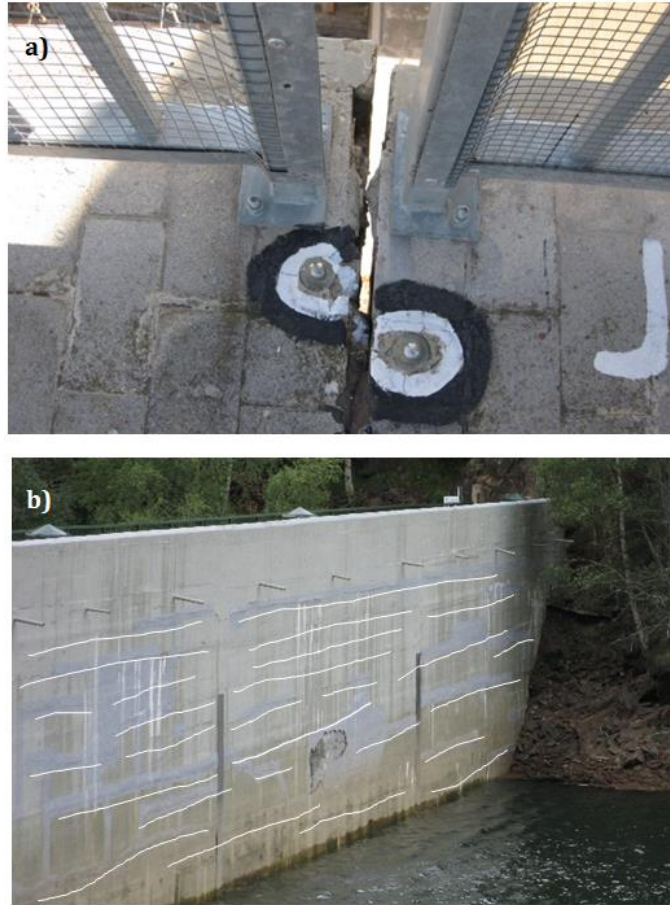
Fig. 5.- Damages in dams: a) remaining movements; b) Fissures upstream face

At the crest, especially in straight plan dams, it is relatively easy to detect both horizontal and vertical remaining movements, which are a clear indication of abnormal behavior in the dam or its foundation. In arch dams, the curvature and the transmission of loads in the longitudinal axis hinder their observation, although they can also be detected. If very notable, the movements can be detected by the variation of the openings of concrete joints or by the misalignment of concrete blocks, as shown in Figure 6a of a 150-m high gravity dam. If the movements are small, the best way to detect them is through the misalignment of slender linear elements, such as rails or handrails.

The walls and spillways are where the largest expanses of visible concrete are found. In addition, these are the areas most exposed to external actions, making them the place to detect pathological signs more easily. Where the reservoir has dropped, the alternation in the state of humidification allows some damage to be detected relatively easily, especially cracks. Figure 6b shows the downstream face of a dam with sealed longitudinal fissures.

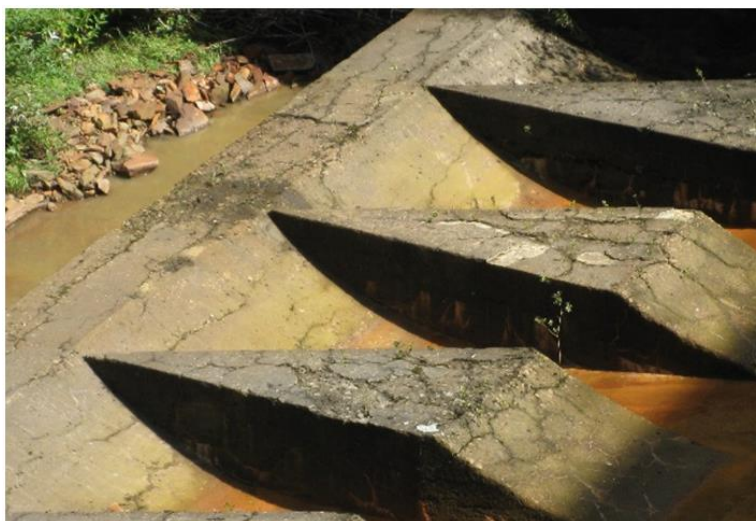
Fig. 6.- Cracks in an annexed structures

Figure 5 illustrates an example of an adjoining structures at a dam with marked cracking that helped determine that the concrete contained reactive aggregates. This image shows the cracking (mapped and longitudinal) of the teeth at the foot of a (heavily reinforced) gravity dam affected by an internal sulfuric attack.

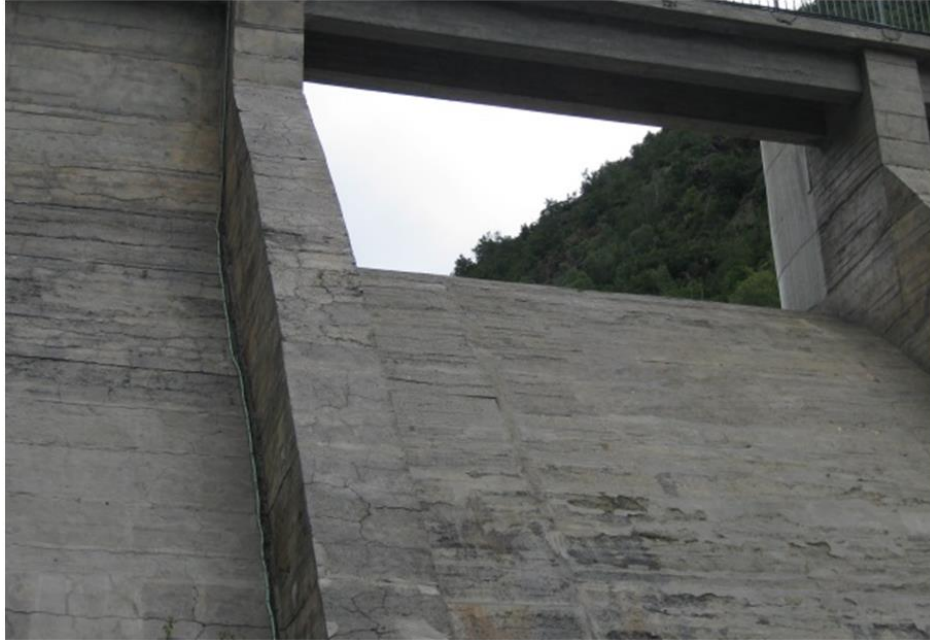
Fig. 7.- Damage in a dam: downstream face body and spillway

In contrast, the downstream face and spillways are easier to study in detail. First, because their entire surfaces are visible to the human eye and, second, because in some cases they can be accessed from a gallery or abutment. Figure 7 shows an example of a damaged downstream face, the spillway of a Catalan dam. This image clearly shows both mapped and longitudinal fissures, in addition to newly formed material seeping from the cracks. Although the cracks are the main indicators in the above examples, there are other

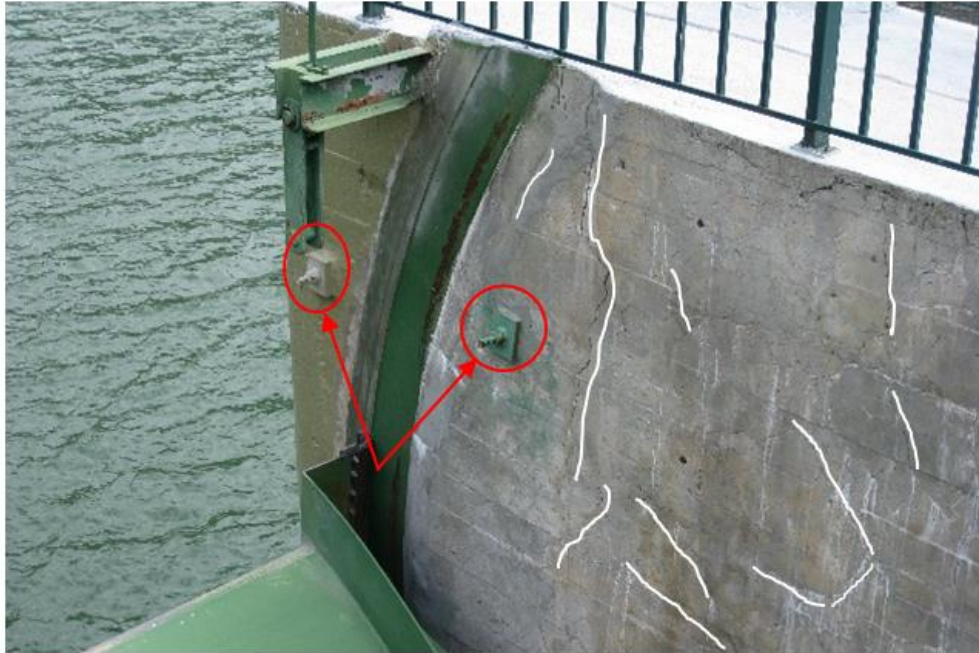
Fig. 9.- Gate area with cracks

This section deals with the important task of inspecting the moving parts, basically sluices and turbines. In such elements, special attention must be paid to jams and changes in the geometry of their openings. Operational problems may indicate a change in the volume of the adjacent concrete. One of the clearest indicators is the gates becoming increasing difficulty to open and close. One of the biggest problems that can occur to a dam is the jamming of a gate. The inability to open it when the hydraulic conditions require it could cause a catastrophe. Concrete cracked from the breakwater where the gate of a dam rests is shown in Figure 9. In this dam, when problems emerged in moving the floodgates, rehabilitation work was carried out that entailed installing anchors to limit the expansive capacity of the concrete.
